√ 6<sup>th</sup> Street & 3<sup>rd</sup> Ave Bus Stop – NE Corner (SunTran # 11852)

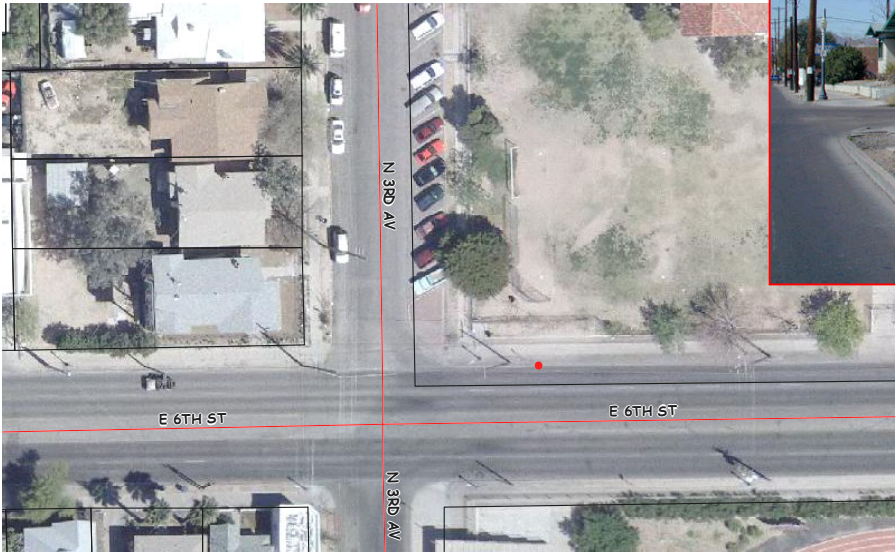
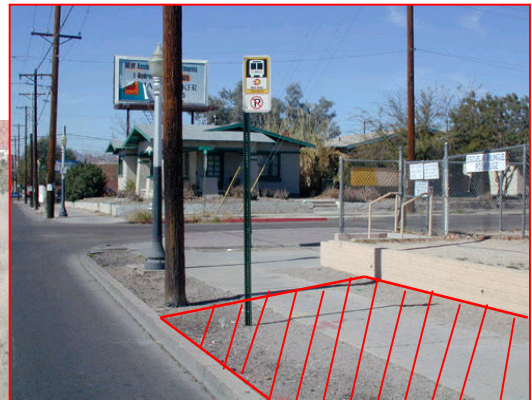
ADA accessibility Score: 4

Issue(s): Stop does not have loading area, has gap between sidewalk and curb

Solution(s): fill gap between sidewalk and curb & fill gap between sidewalk and retaining wall to create space at least 8' deep x 5' wide (minimum) preferably replace existing sidewalk with new concrete loading pad 22' long x 12' wide x 6" deep – start @ existing bus stop sign

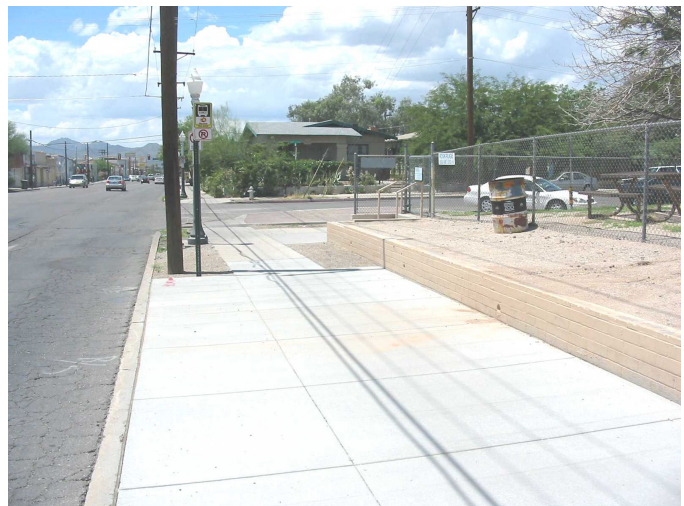
**Stop completed:** shelter pad built, and stop no longer has gap between curb and sidewalk. Accessible for all bus stop users.
